KILLYBEGS FISHING PIER IMMERSED PIER LEGS - IRELAND

Department of the Marine and
Natural Resources
Killybegs FHC
Refurbishment of Piles in Landing Pier
and Blackrock Pier
Post Maintenance Inspection

**KILLYBEGS F.H.C. PILE
REFURBISHMENT**

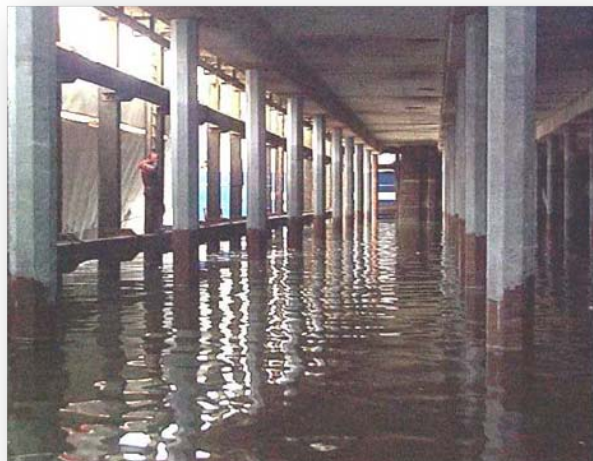
These pictures of the pier legs were taken in August 2001: one year after the application.

The ZINGA is holding perfectly with no rust showing. Any marking on the legs is either seaweed or harbour contaminants.

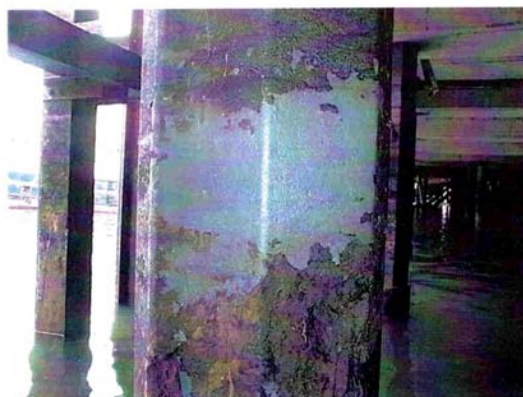
Plate 1. Area of pile cleaned for inspection

The general condition of the Zinga coating was found to be good with only small amounts of rusting found in areas where very limited access had prevented proper preparation and

application, i.e. to the bottom of the piles to row A, that are surrounded by rocks and the tops of the piles to row Z which are surrounded in steel work. The hardness of the coating was

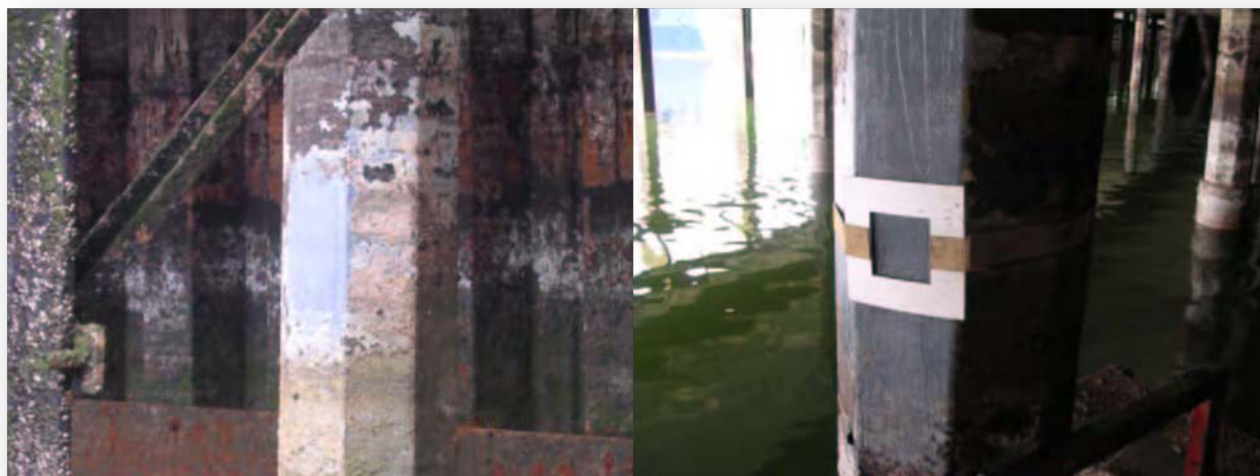
In July 2003 SGS Axa-Med has done the first official inspection of the pier legs after 3 years of service. There was no significant change in the layer thickness of the ZINGA. Some minor repair work had to be done on piles that had received an insufficient surface preparation at the time of the application on areas that were difficult to reach. Hereafter you can read an extract of the inspection report and view the pictures that were taken.

Brief conclusion	See paragraph
Some minor repair work has to be done on piles with areas difficult to reach. The cleaning of the reference piles with HP (warm) water didn't give any problem. The all-over dry film thickness hasn't change significantly.

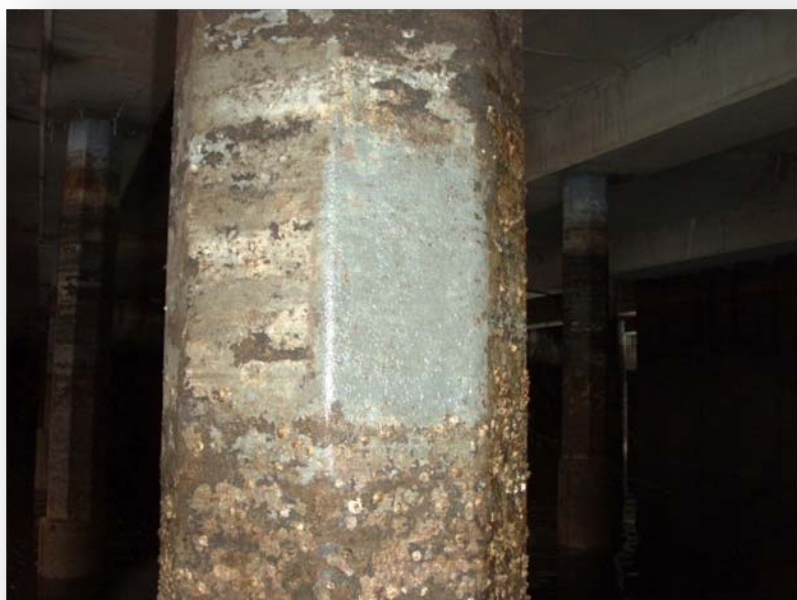
The piles didn't show any significant progress in corrosion since the last inspection in 2006 (after 6 years in service). Only on the piles at the Blackrock Pier we saw slight corrosion on the upper 0.5 to 1 m. The touch-up done before and during the last inspection in 2006 shows some blistering. This is probably caused by remaining salts underneath. The overall thickness has not significantly changed.

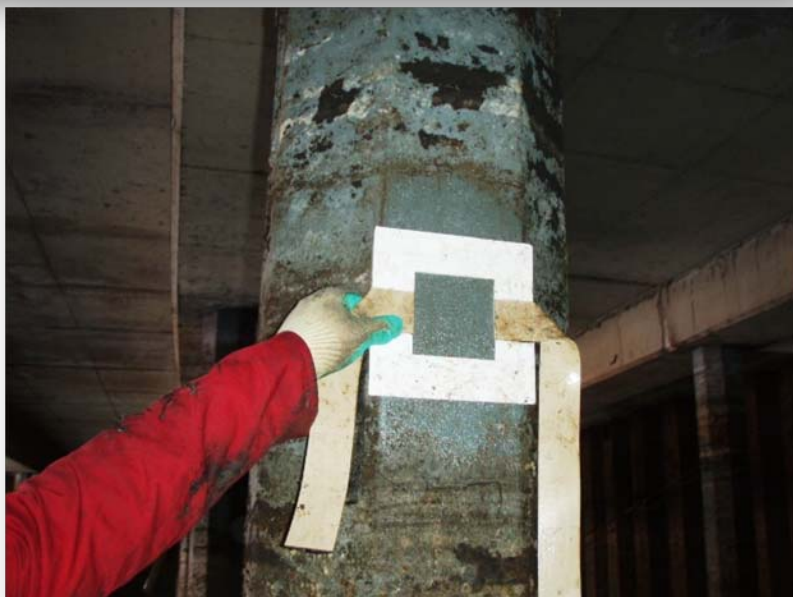
The coating is at present in quite good condition; if well maintained, the system can remain in service for another 10 years.
