## STROM UND HAUFENBAU HAMBURG HARBOUR COMPANY - GERMANY

In 1989 an oil storage tank was coated with Zinga by the engineering office of Strom- und Hafenbau Hamburg.

Betreff: Testbeschichtung, Tank 12, HÖG, Hamburg  
Abschlußbericht nach 10 Jahren Standzeit

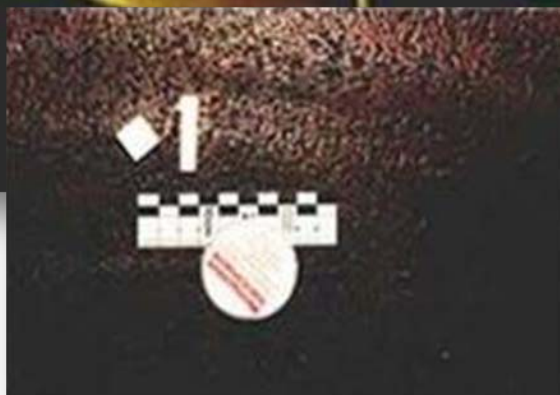
Detail of the surface before treatment in 1989.

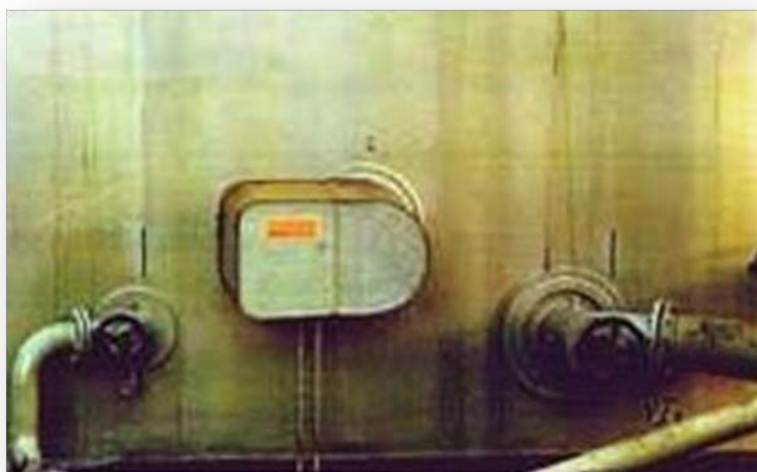
The tank was evaluated after 10 years. The coating system was still in a perfect condition. You will find a testimonial letter from Strom- und Hafenbau on the next page. As a result of this successful test application, the whole tank storage was painted in the course of the year 2000 with this system.

On the left you see a detail of the condition of the tank in 1999.

Since 30/08/89 until today there was no deficiency in quality on the existing sample surface treated with the supplied product : AGESO KALTZINK HS 300 which had to cope with a severe industrial climate.

Only some small, mechanical damage was visible, but this was due to a lot of manipulation in between, such as mantling etc. and not due to the coating system itself.
