## **REPORT NR. 16/351**

**SUBJECT: Investigation into the mixing of**  
**ZINGA coatings**

Investigation into the mixing of ZINGA coatings

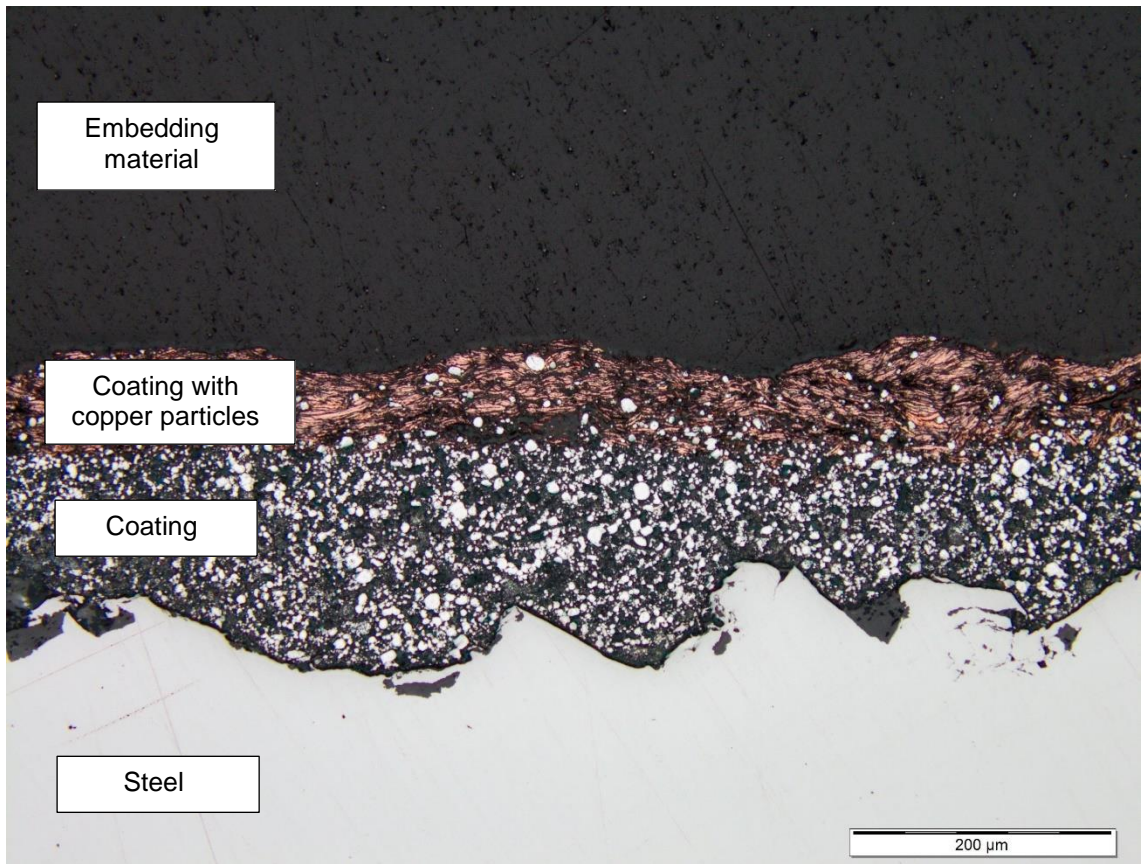
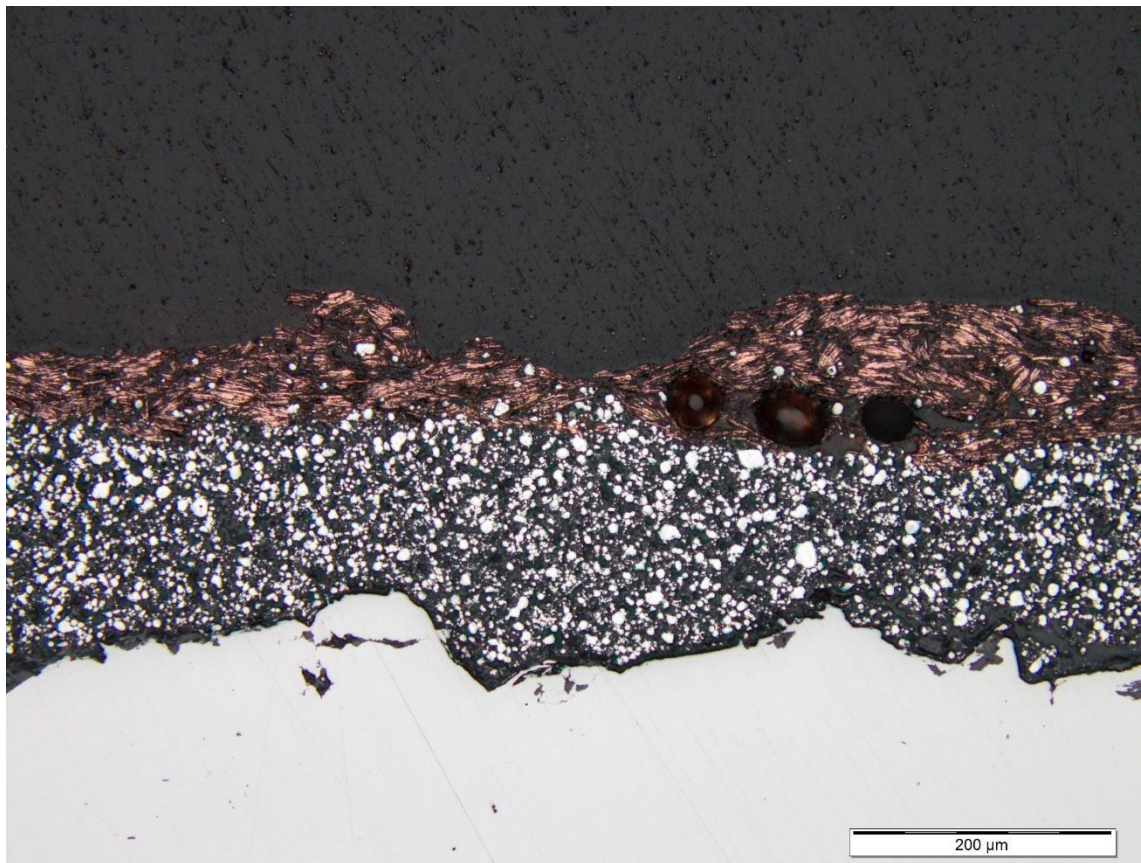
Figure 3: A-1

Sample A shows a ZINGA layer with a layer of copper particles on top (Figure 3 and Figure 4). Sample B shows a mixed copper and ZINGA layer (Figure 5 and Figure 6). Copper particles are observed throughout the thickness of the coating. This means that the second ZINGA layer has mixed with the first ZINGA layer.

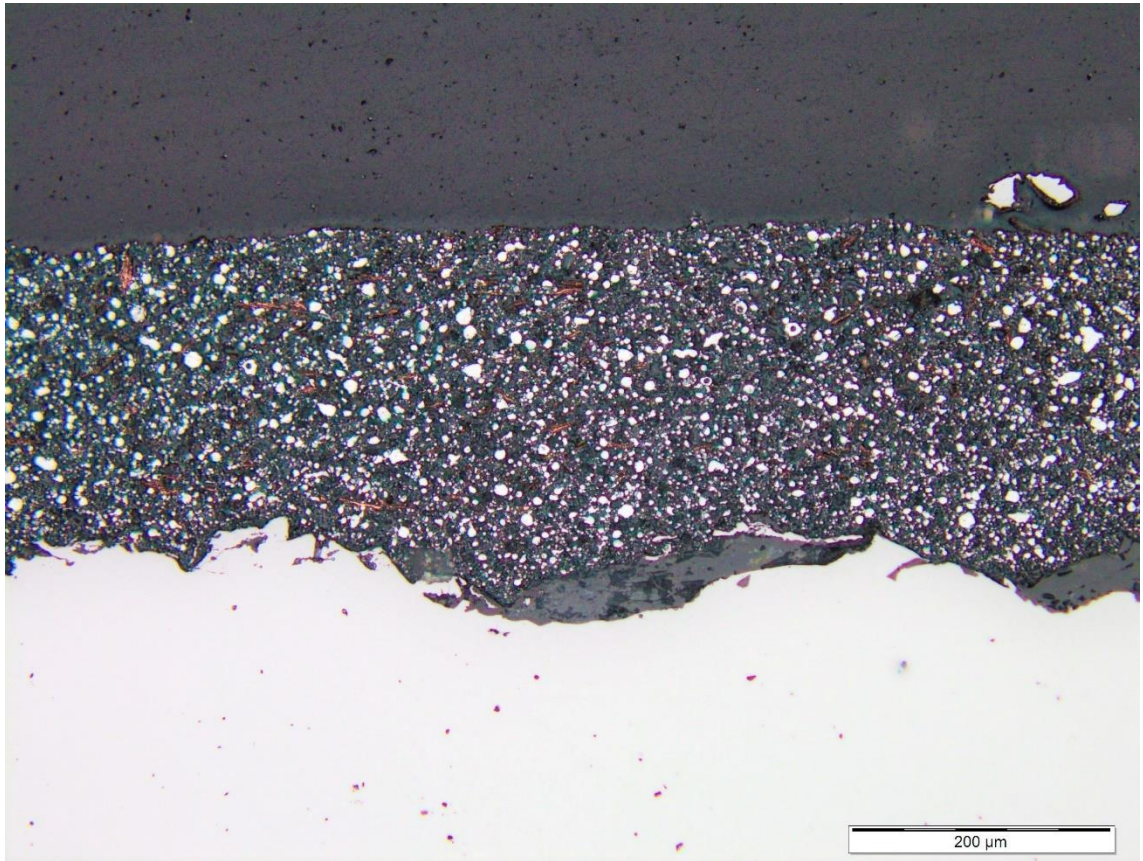
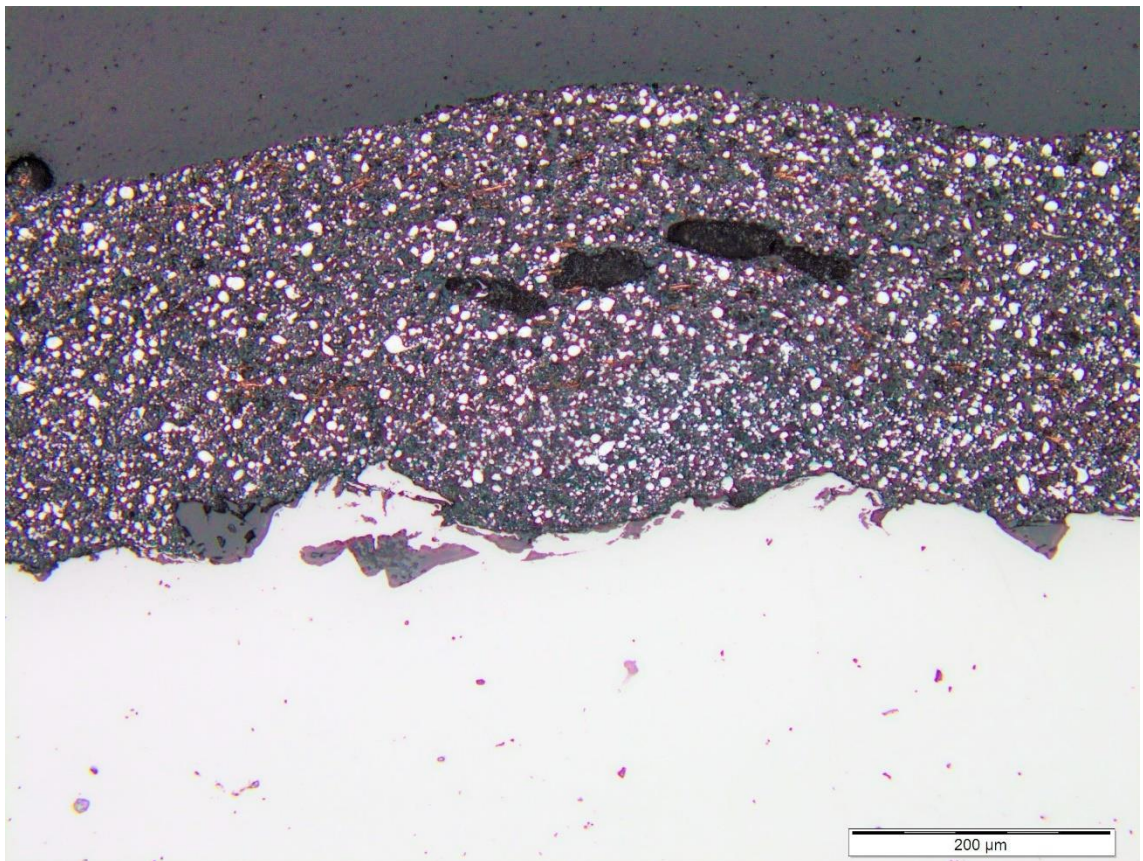
Figure 5: B-1.

On sample B, copper particles are observed throughout the thickness of the coating. This means that the second ZINGA layer has mixed with the first ZINGA layer.

This result shows the mixability of the ZINGA coating with previous ZINGA coating layers.

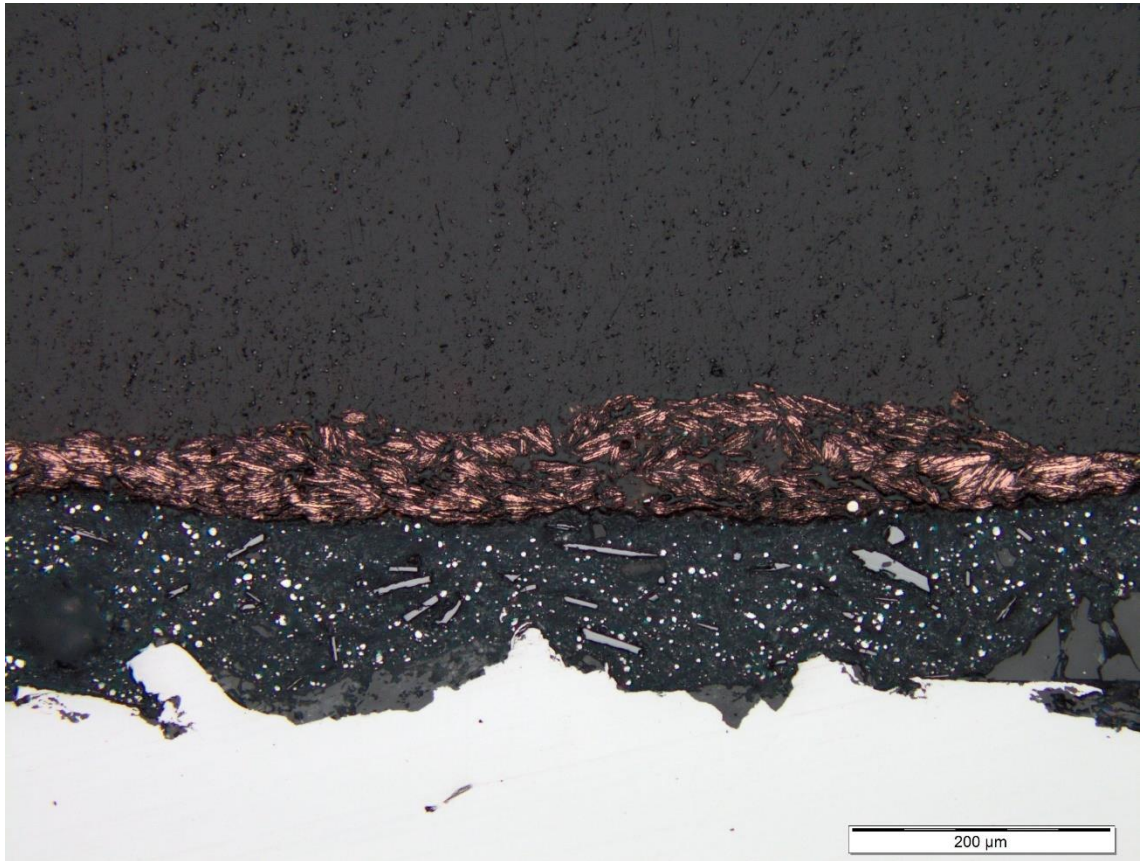
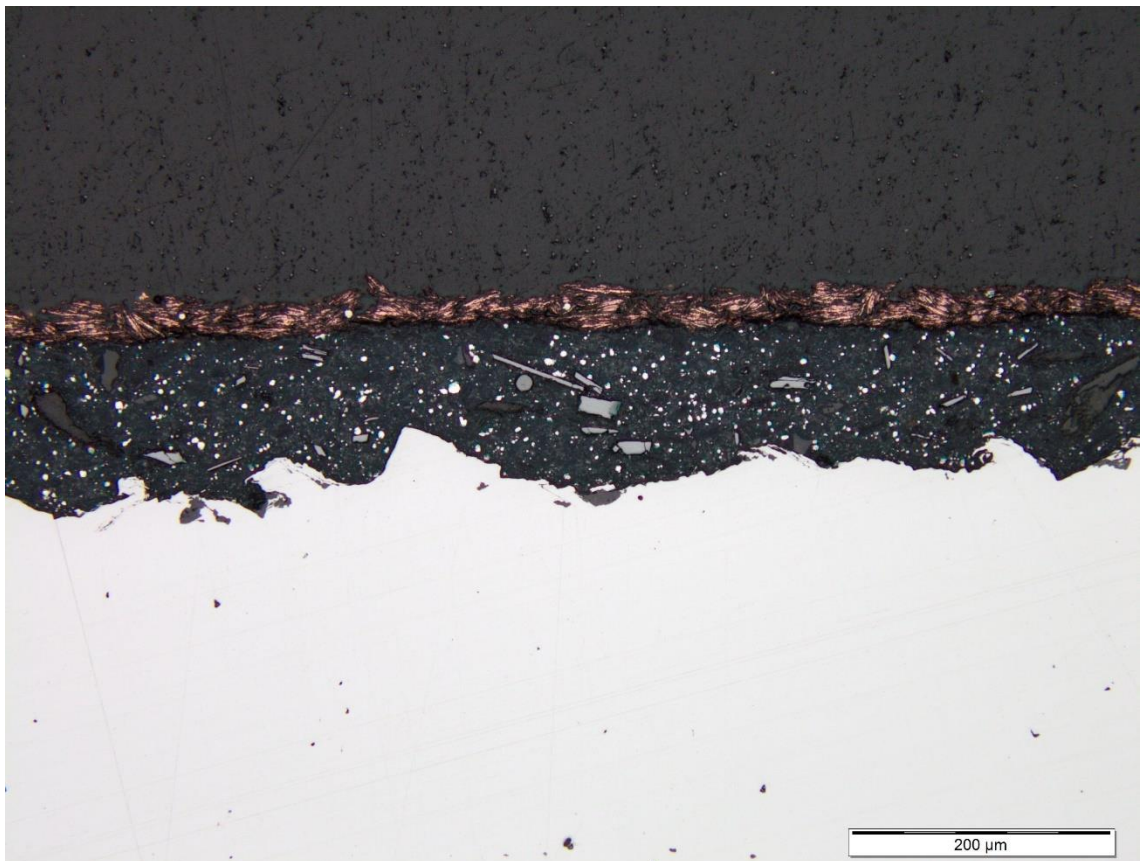
Figure 7: C-1.

Sample C shows a zinc primer layer with a layer of copper particles on top (Figure 7 and Figure 8).

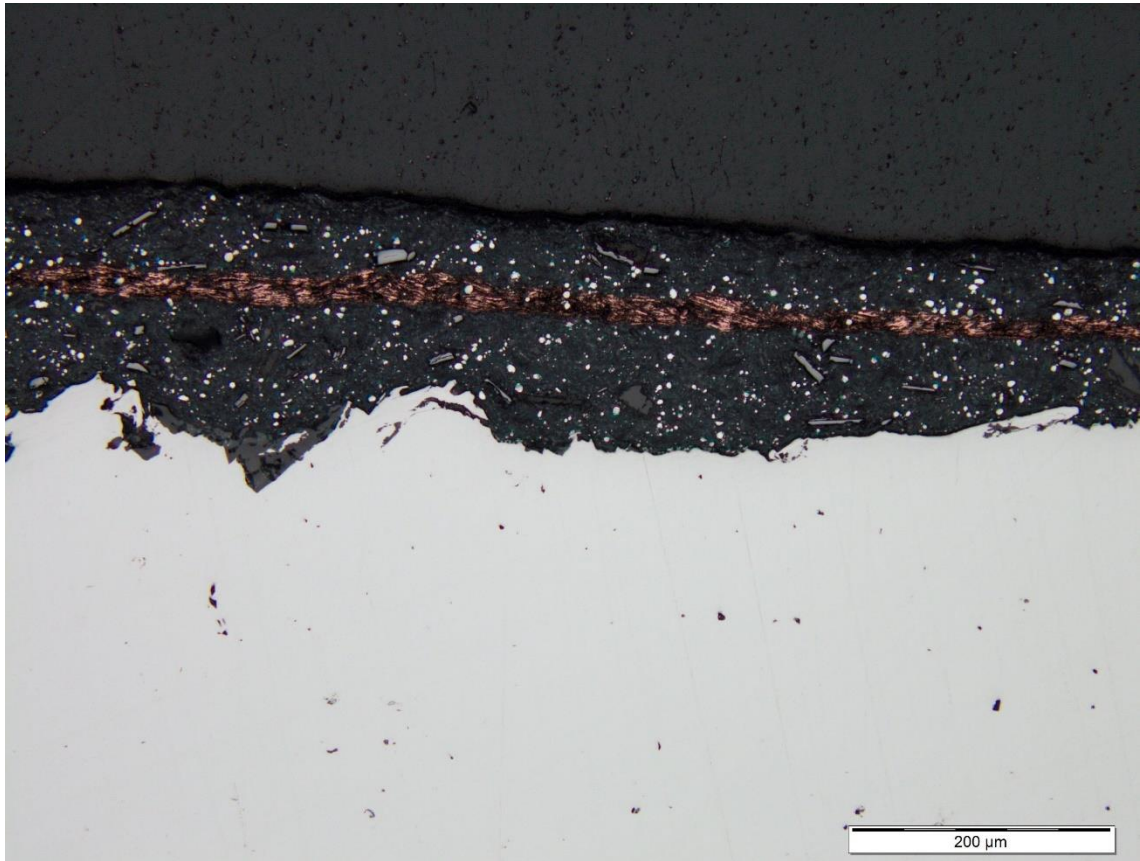
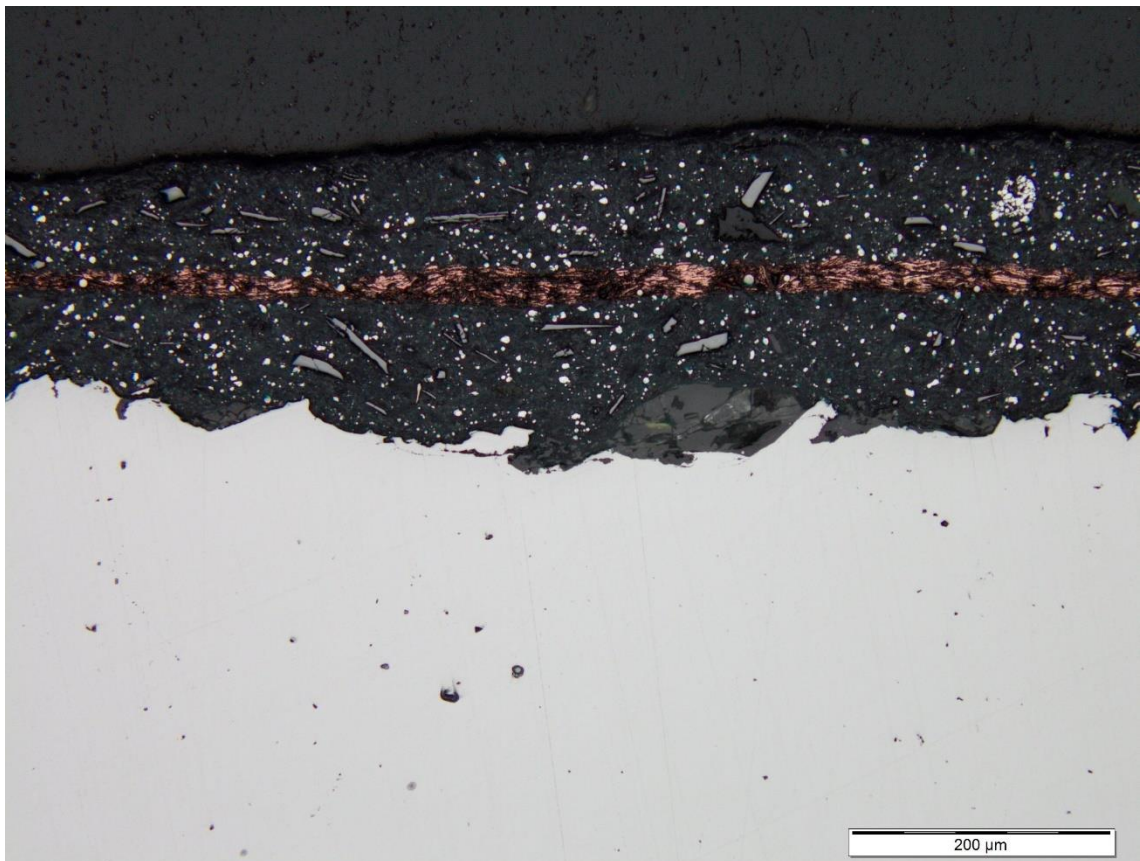
Figure 9: D-1.

Sample D shows a distinctive layered pattern of the first zinc primer layer on the steel, covered by a layer with copper particles, covered by the second zinc primer layer.

This result shows that the zinc primer is not mixable with previous zinc primer layers.

Sample D shows a distinctive layered pattern of a zinc primer layer on the steel, covered by a layer with copper particles, covered by a zinc primer layer (Figure 9 and Figure 10). The copper particles did not mix with the zinc primer coating.
