APPLICATIONS ON REBARS

Protection of reinforcement bars in concrete

Protection of rebars in concrete

Report concerning the pull-out test performed on uncoated and Zinga coated rebars for

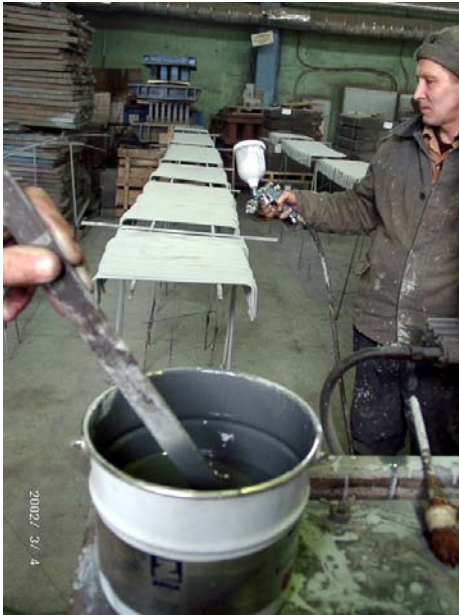
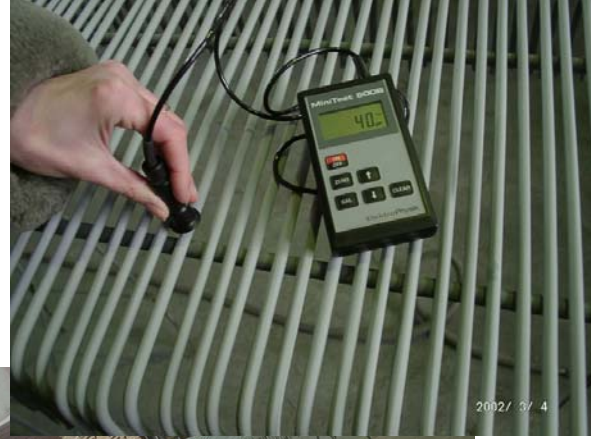
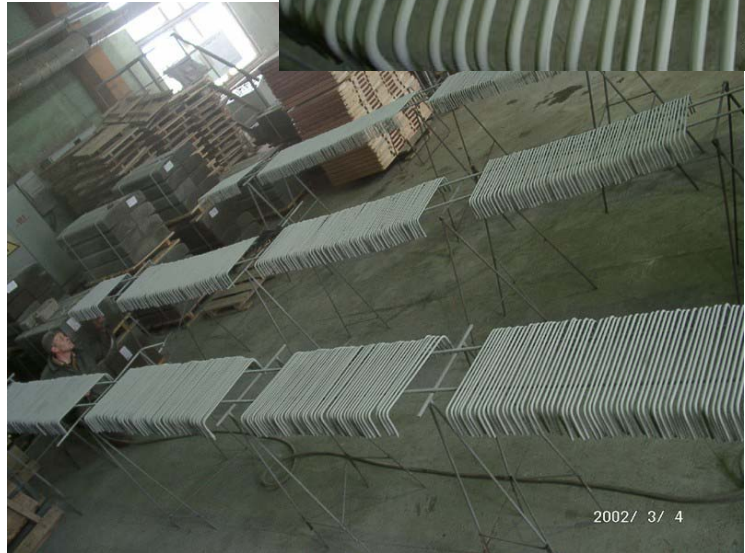
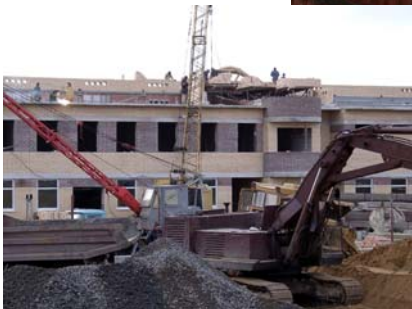
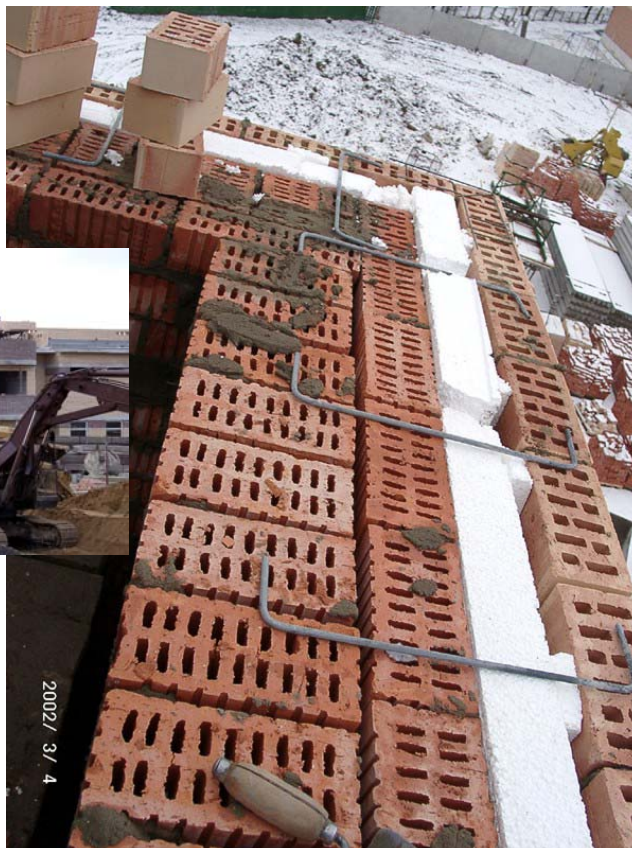
Building with Rebars - Russia

In March 2002 ZINGA was applied on rebars to reinforce the walls of a large building in Russia.

These pictures were taken during the ZINGA application in the work shop and during the construction of the building.

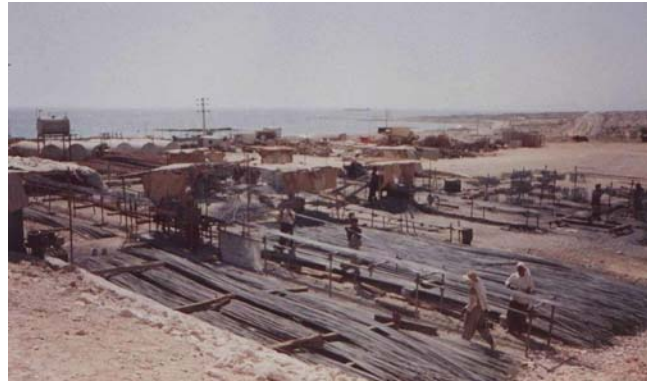
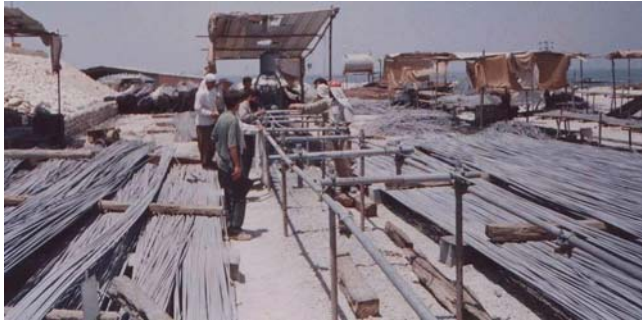
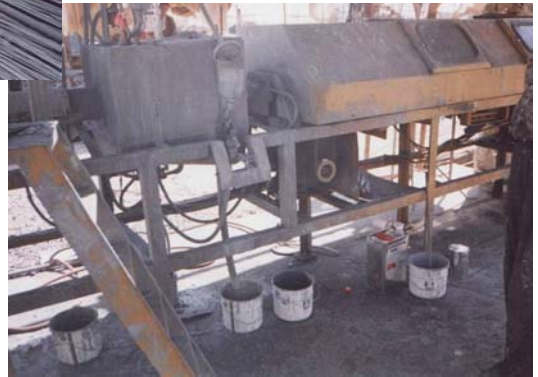
National Iranian Gas Company - Rebars - Iran

In December 2001 the National Iranian Gas Company has used ZINGA for the protection on rebars to reinforce the concrete walls of large round containers, during the construction of a sulphur export port in the special industry zone in Assaluyeh.

For the application of ZINGA they used a specially designed spraying machine for rebars.

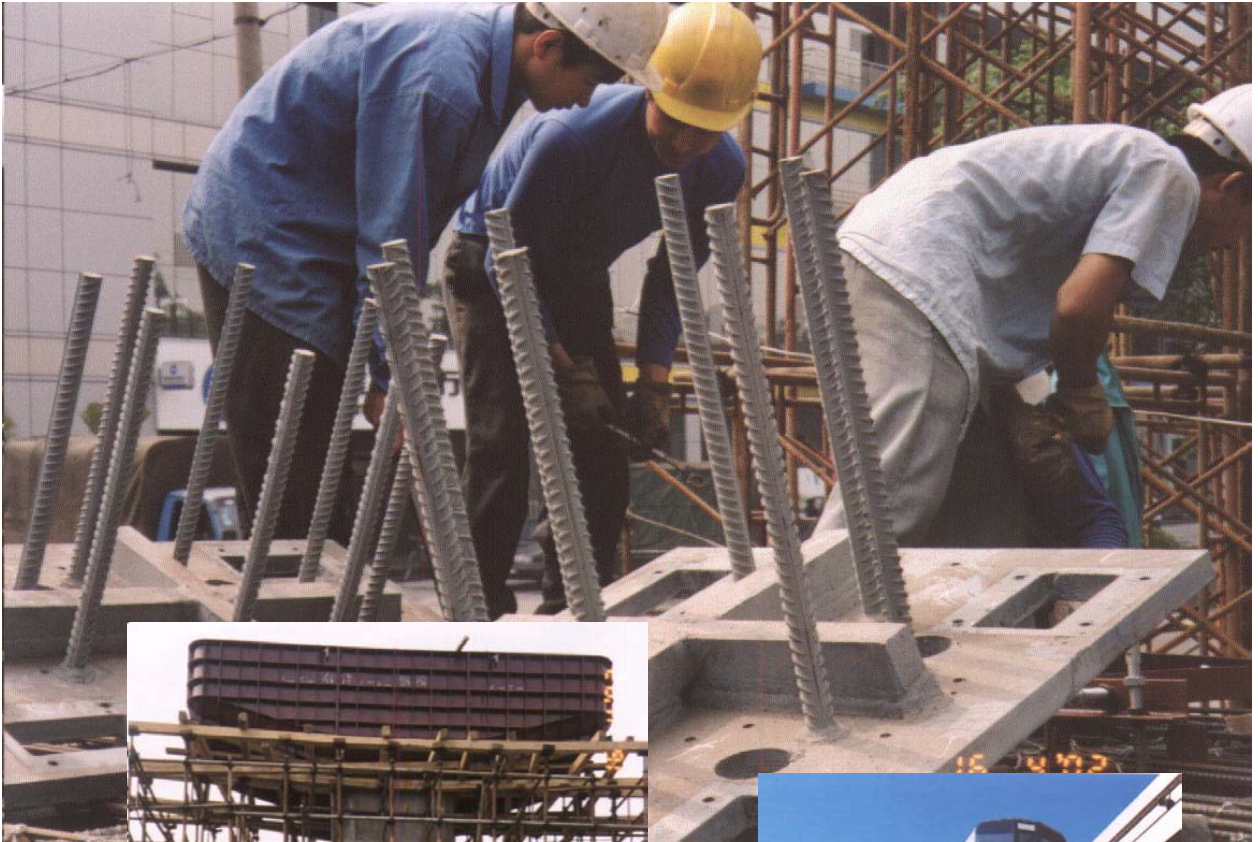
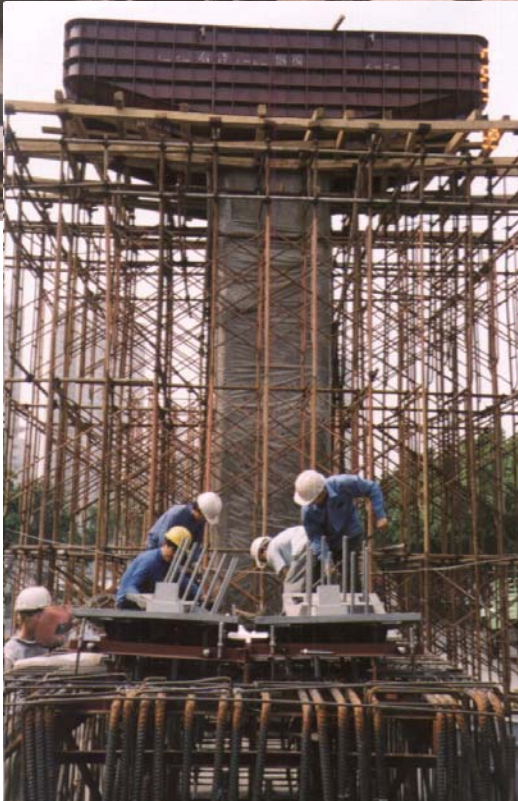
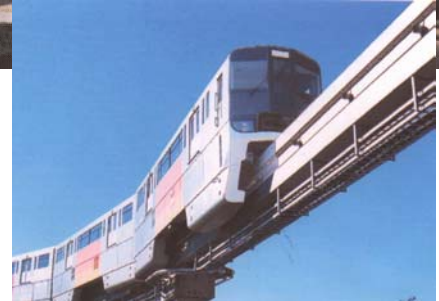
Chongqing Water Turbine Works Company Contractor - Rebars - China

The company Chongqing Water Turbine Works (CWTW) is one of the main contractors for the construction of the Chongqing Monorail. The CWTW has applied ZINGA with satisfactory results on the rebars of the beam supports, directing splitter tracks and connecting plates. These pictures were taken on 16/04/02.
