WESTHINDER – LIGHTSHIP - BELGIUM

The lightship "Westhinder" has been treated with ZINGA in 1998. After sandblasting to a degree of Sa 2.5, ZINGA and topcoats were applied.

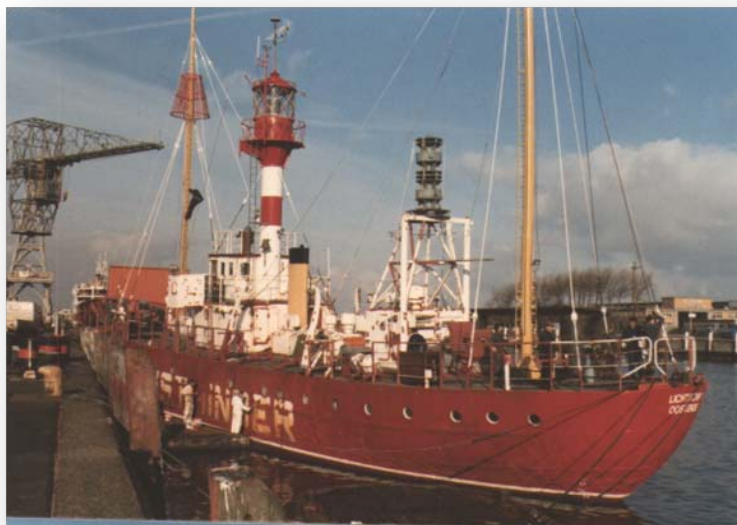
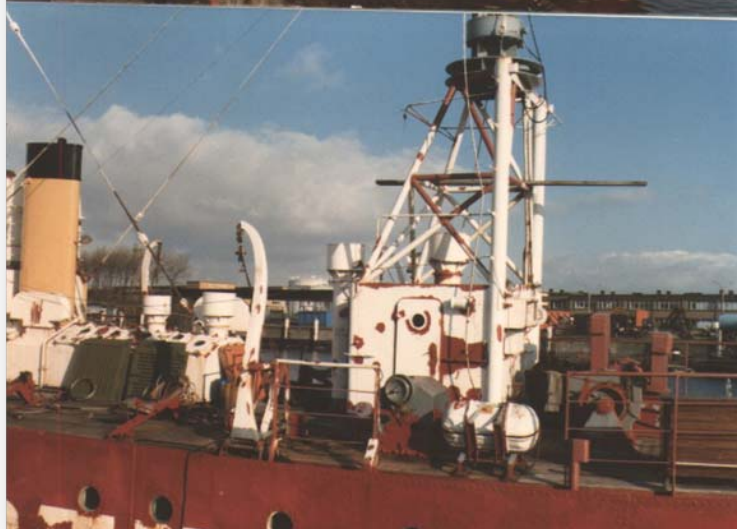
Pictures of the Westhinder before the renovation started.

Above the water line, 1 x 80 μ m ZINGA was applied, overcoated with 2 C Epoxy Sealer MIO and Uretex Navy.

The same system was used under the water line, with an additional anti-fouling layer.

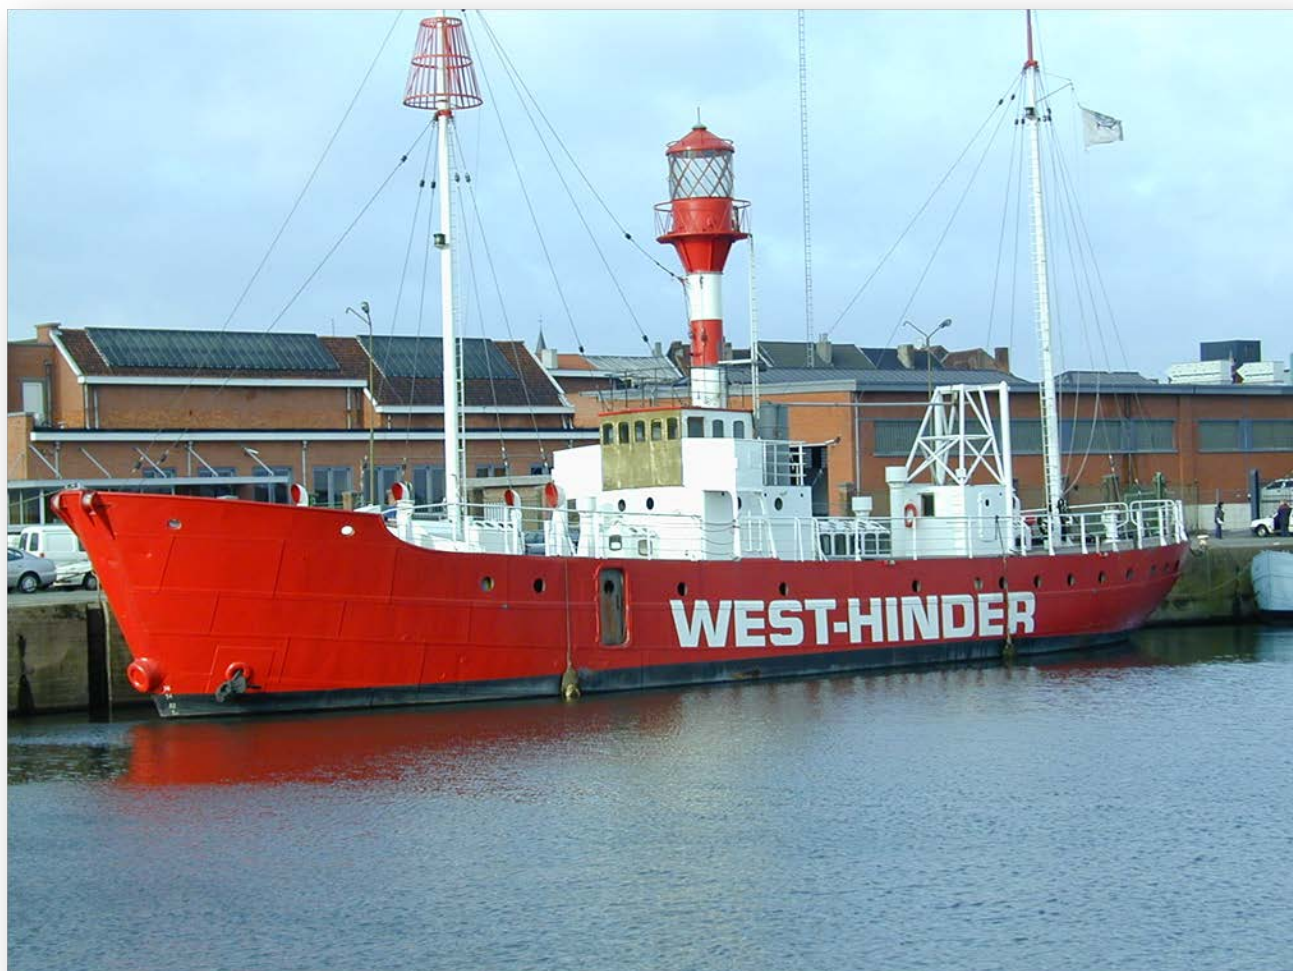
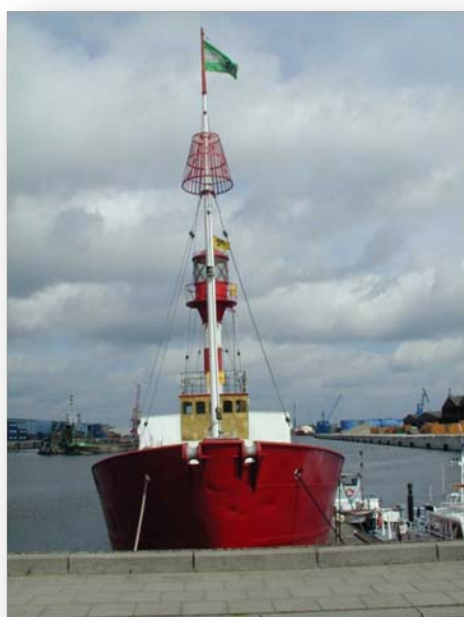
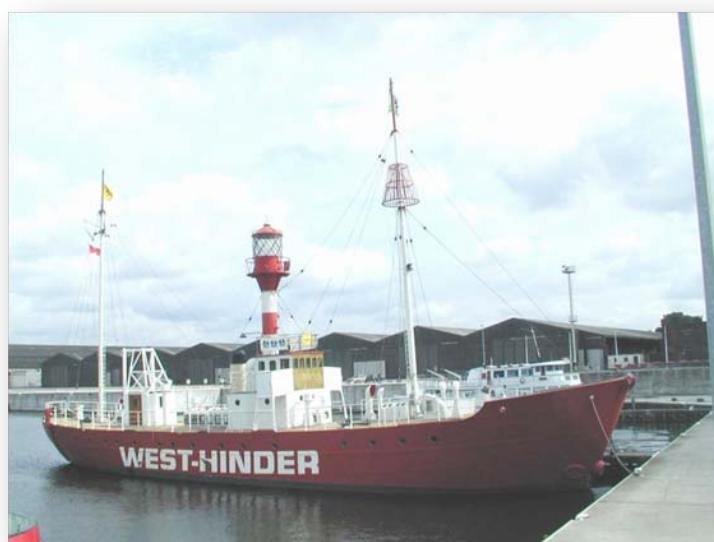
Pictures after ZINGA application and topcoating.
