## **REPORT NR. 16/351**

**SUBJECT: Investigation into the mixing of**  
**ZINGA coatings**

Investigation into the mixing of ZINGA coatings

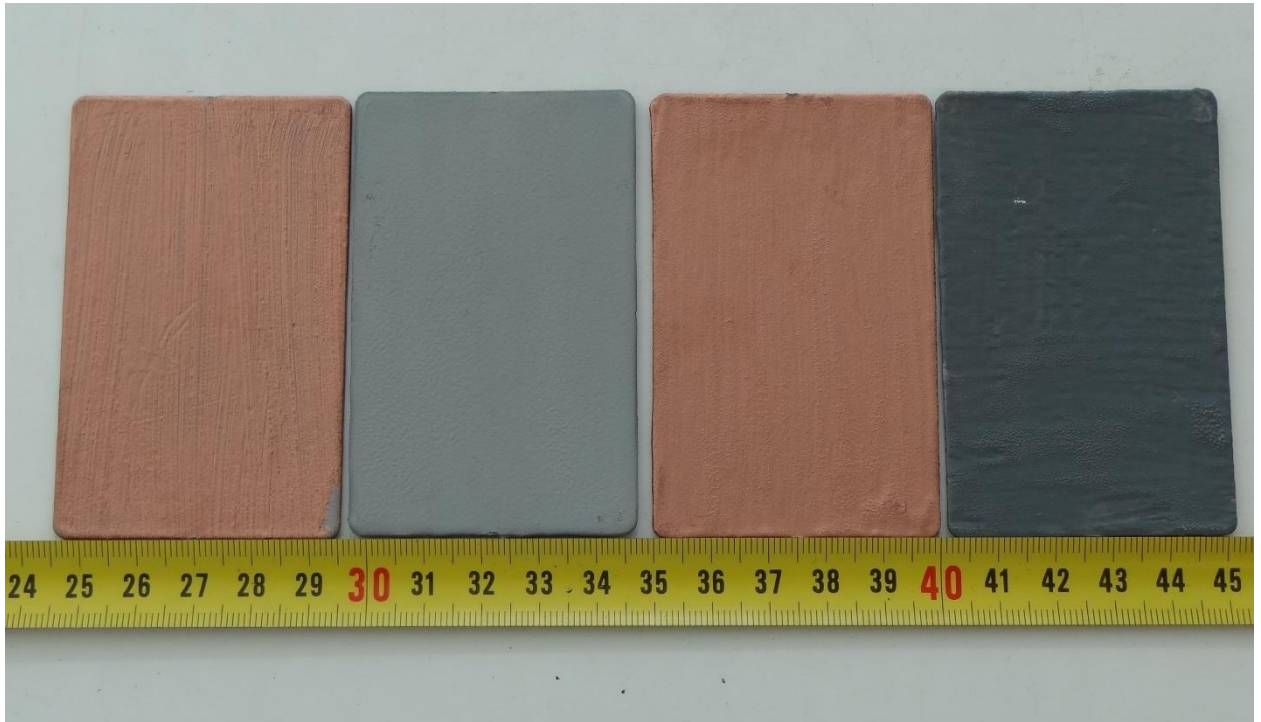
Figure 1: Samples received. From left to right: A to D.

The Belgian Welding Institute (BWI) received four coated steel samples. Both sides are shown in Figure 1 and Figure 2. Samples are given BWI-reference A to D. The coating is as follows:

- A: ZINGA + copper
- B: ZINGA + copper + ZINGA
- C: Zinc primer + copper
- D: Zinc primer + copper + zinc primer

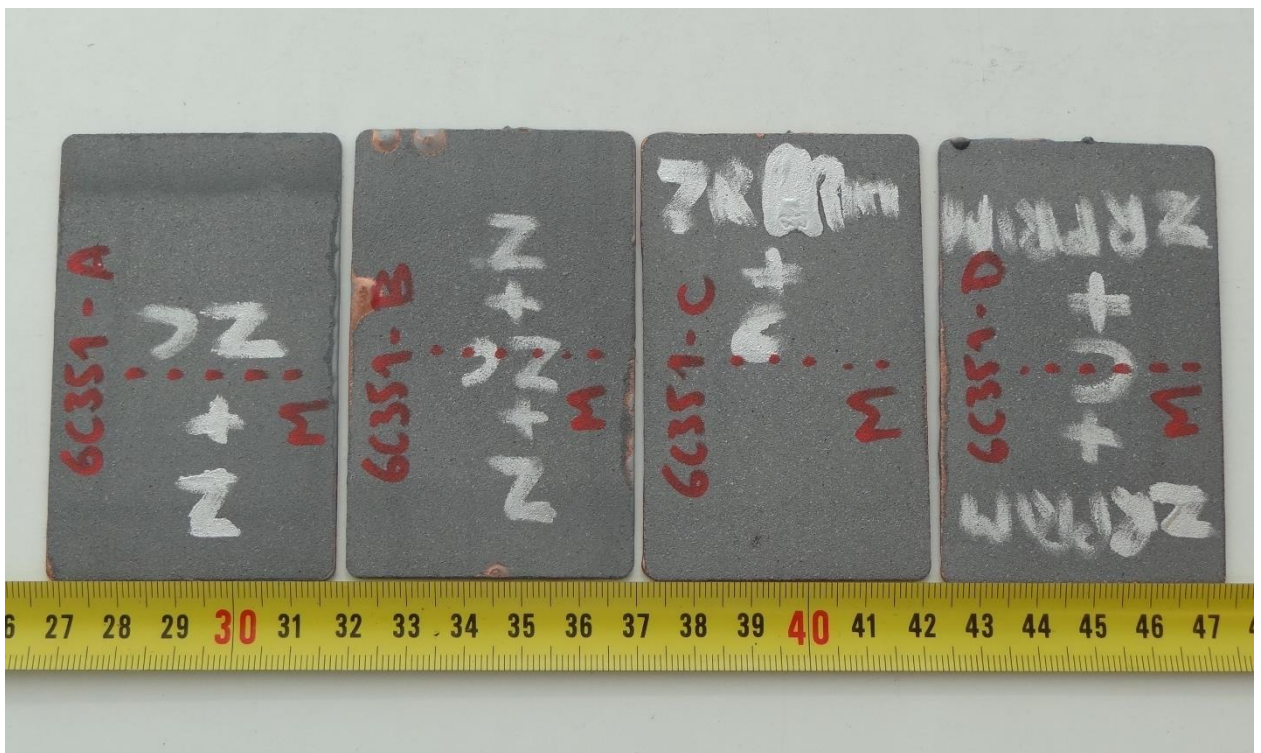
Figure 2: Indication of sampling location.

Samples are cut in the center (see Figure 2). After embedding, grinding and polishing, the samples are examined by light microscopy. All pictures are taken at the same magnification.
