KILLYBEGS FISHING PIER IMMERSED PIER LEGS - IRELAND

Department of the Marine and
Natural Resources
Killybegs FHC
Refurbishment of Piles in Landing Pier
and Blackrock Pier
Post Maintenance Inspection

**KILLYBEGS F.H.C. PILE
REFURBISHMENT**

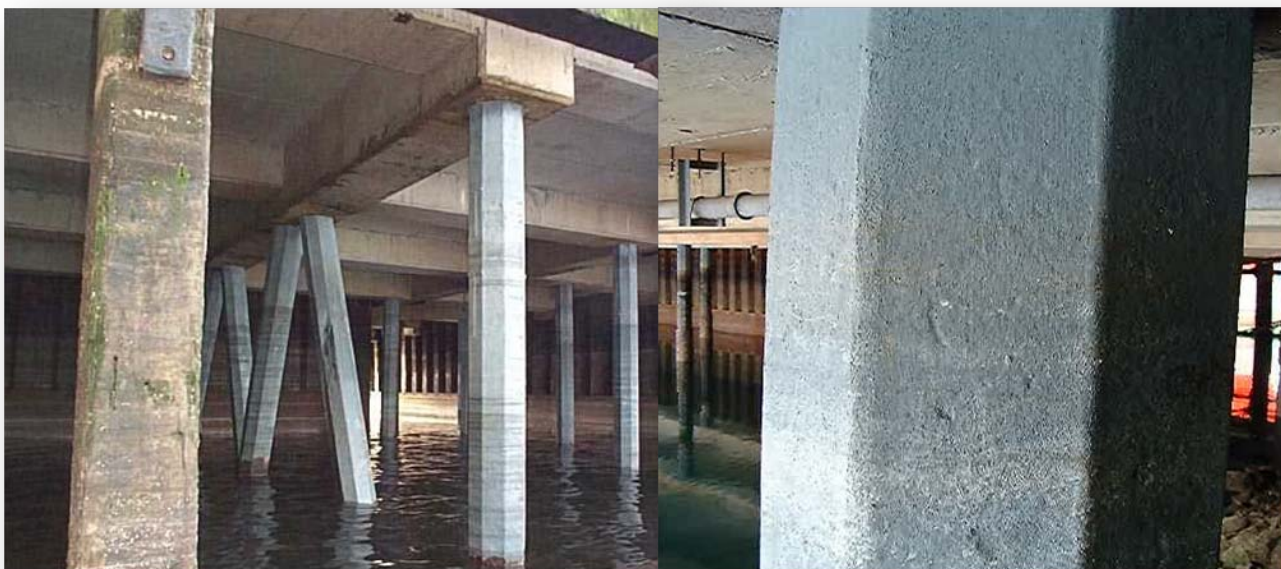
These pictures of the pier legs were taken in August 2001: one year after the application.

The ZINGA is holding perfectly with no rust showing. Any marking on the legs is either seaweed or harbour contaminants.

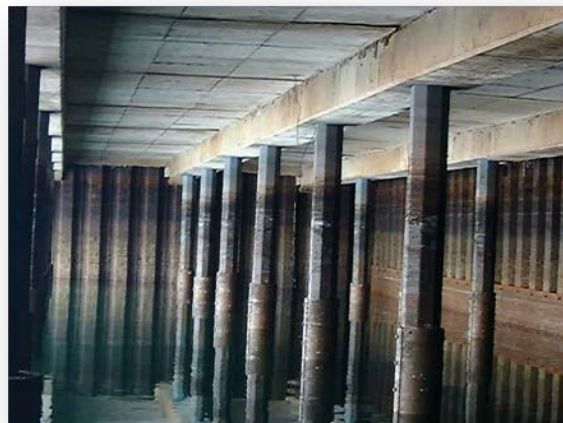
The piles were prepared by UHP water-jetting and blasting to SA 2.5 with Rz 40 to 60 μm . The application happened under severe surveillance of SGS Axa-Med, because it was a very difficult and delicate application as they had to take into account the tidal movement of the water and the constant contact with sea water. SGS Axa-Med had prescribed a dry film thickness of ZINGA of $25 + 40 + 40 + 40 \mu\text{m} = 145 \mu\text{m}$, but in the end an average of 300 μm was measured.

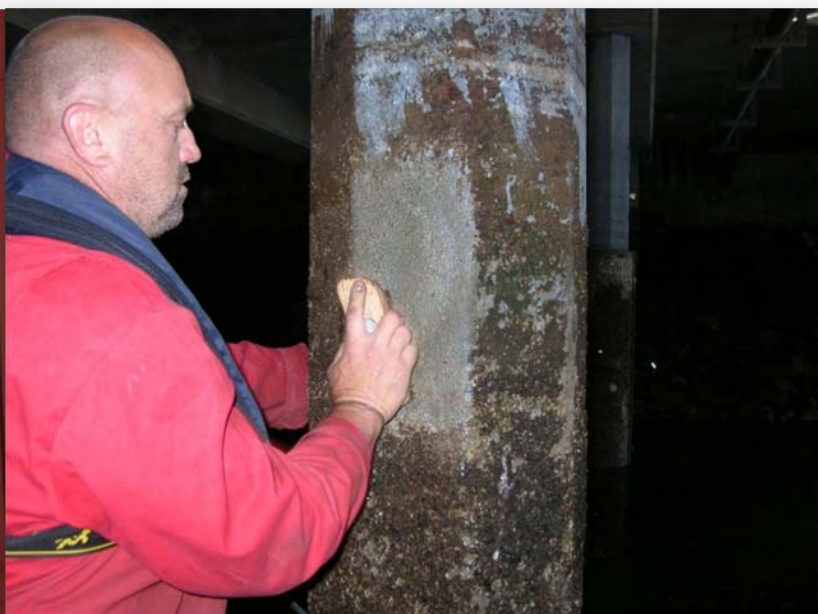
In July 2009, a third inspection took place, 9 years after the application and the results are very good. ZINGA protects the metal of the pier piles very well, even in these very harsh conditions.

The piles didn't show any significant progress in corrosion since the last inspection in 2006 (after 6 years in service). Only on the piles at the Blackrock Pier we saw slight corrosion on the upper 0.5 to 1 m. The touch-up done before and during the last inspection in 2006 shows some blistering. This is probably caused by remaining salts underneath. The overall thickness has not significantly changed.

The coating is at present in quite good condition; if well maintained, the system can remain in service for another 10 years.
