CONCRETE CONSTRUCTION

A Jointless, Crack-Free Walkway

A concrete expert experiments at his own home

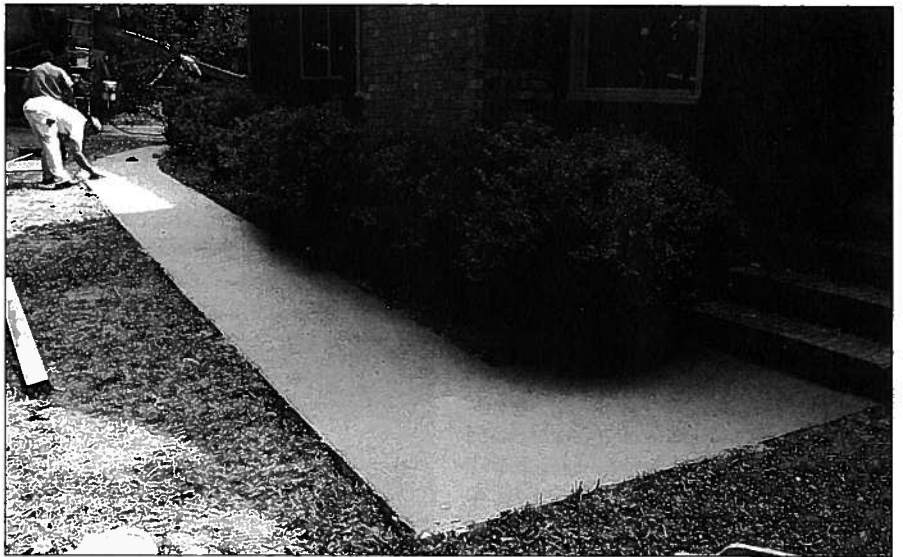
This walkway with re-entrant corner at one end and a curve at the other with no joints remains crack-free after more than three and a half years.

inch-thick walkway with no joints, a 90-degree turn at one end with an unreinforced re-entrant corner, and an 80-degree curve at the other end. After more than three and a half years of shrinkage and substantial thermal contraction due

to a drop in temperature of about 90° F, there are no visible cracks—even at the re-entrant corner.

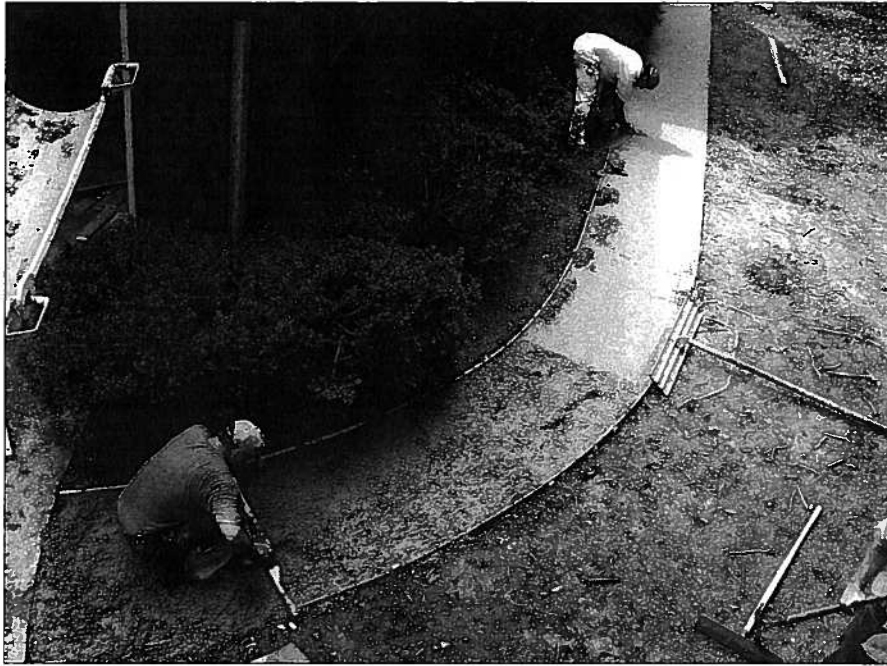
The crew struck-off, floated, and edged by hand.

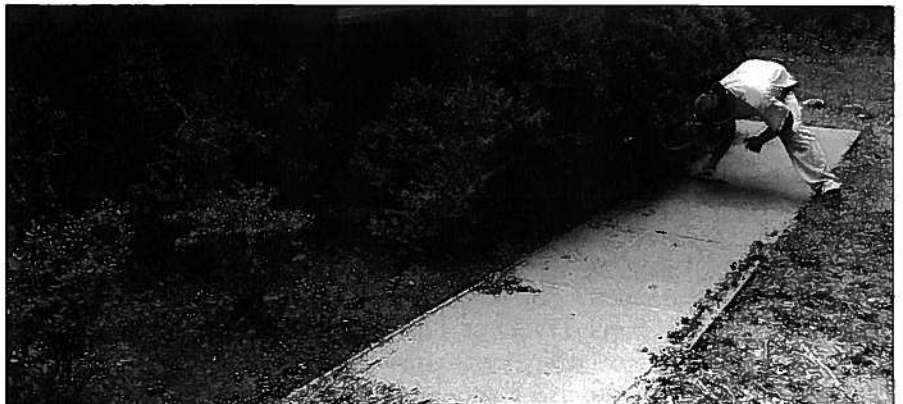
Holland and crew found placement and finishing to be no more difficult than normal, in spite of the high volume of fibers.

for hand placement, Holland added enough water to the last portion of the concrete to increase the slump by 1 inch, to about 4 inches. They did not find that a significant improvement. Holland and crew broomed the slab transversely in one direction in order to make the fibers lay down. The high volume of fibers did not cause any problems during brooming and were nearly invisible unless one looked very closely. The entire crew agreed that the finishability was such that if it had not been an exterior slab, they could have achieved a highly polished steel-troweled finish. Holland then cured the walkway for seven days with polyethylene sheeting.

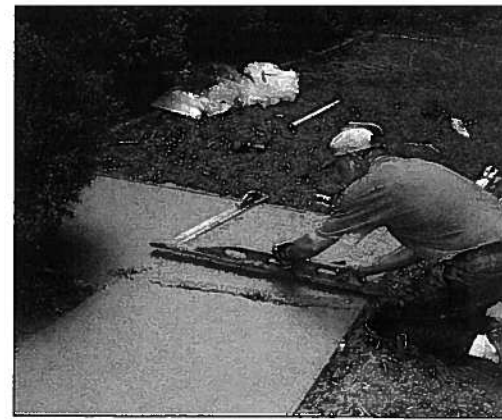
Cecil Bentley using a wooden darby to float the near the edges.

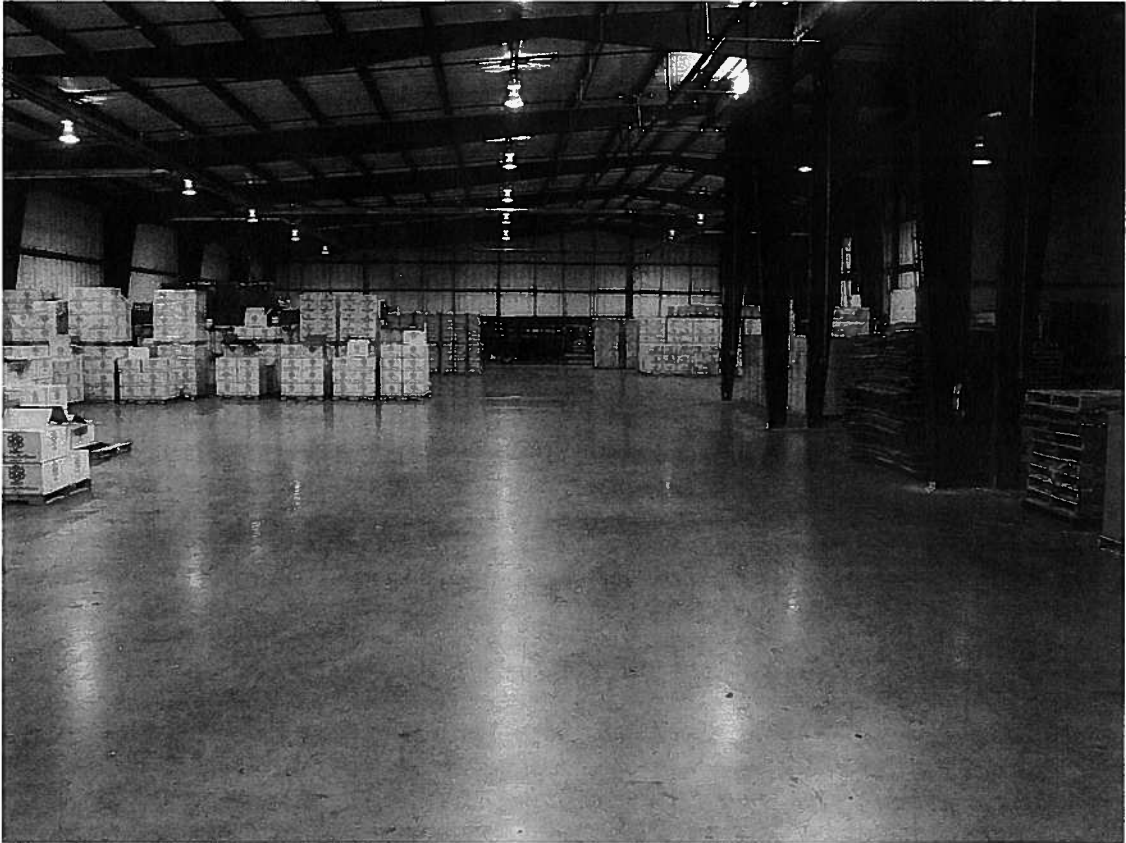
Slab #1 of FORTA addition (127 feet x 60 feet) is crack-free with no steel reinforcement and no control joints.
