CHONGQING BROADCASTING COMPANY - CHINA

In July 2001 the Chongqing Broadcasting Company has constructed a new TV transmission tower.

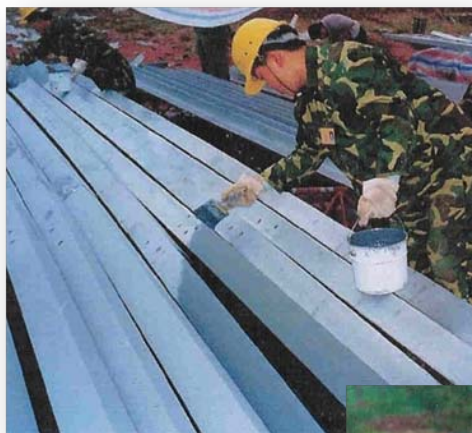
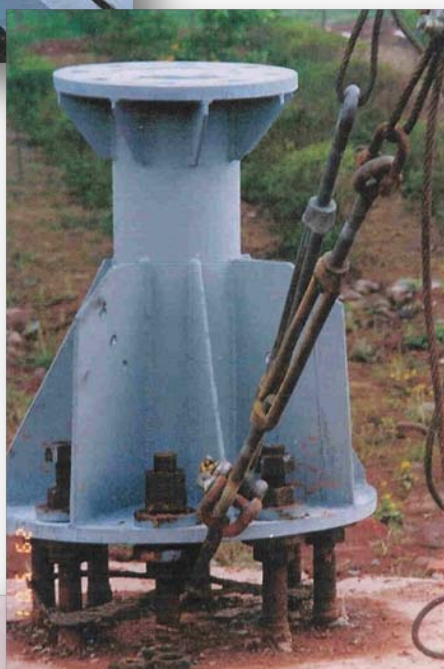
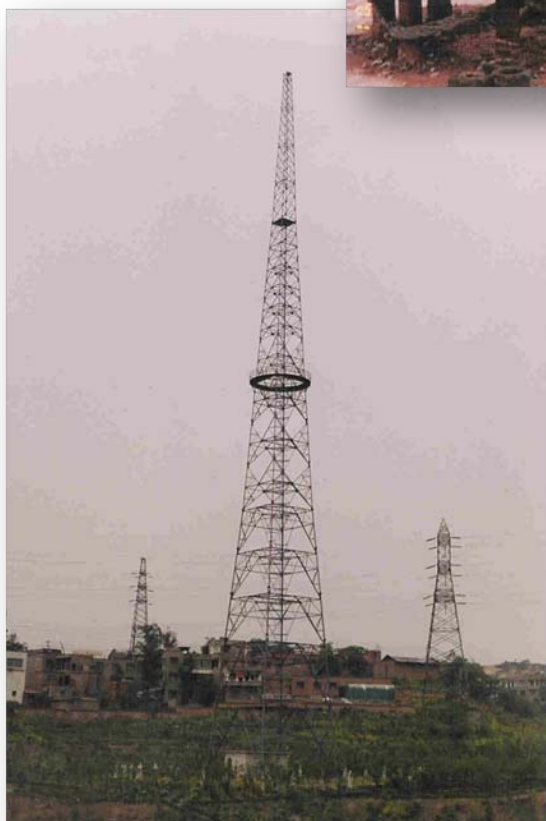
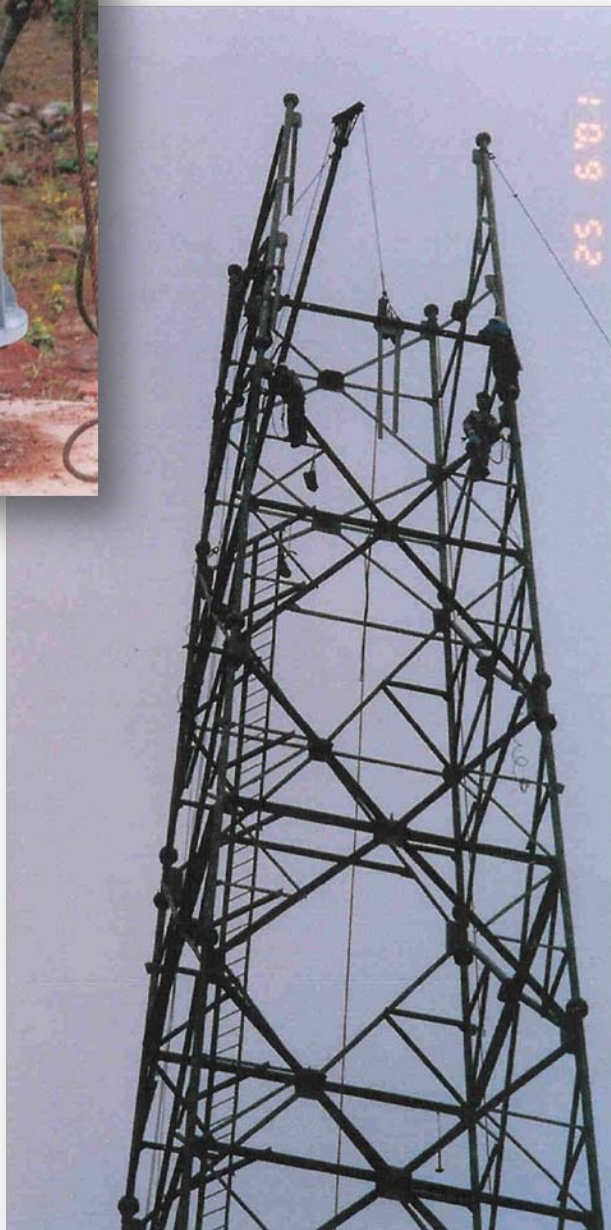
ZINGA was applied on top of hot-dip galvanised steel. The hot-dip galvanising layer was new but due to its bad quality, it had already started to rust. It was roughened by means of a chemical etching product.

The site was inspected in April 2002 and the Zinga was found to be in excellent condition.

Hot-dip	1 x 90 µm
ZINGA	1 x 40 to 50 µm
