MOLISSON STREET BRIDGE- AUSTRALIA

The Molisson Street Bridge is situated in Kyneton, Northern Victoria, Australia and has served the past 100 years for traffic over the Compaspe River.

It is the first steel bridge structure treated with ZINGA for VicRoads Design.

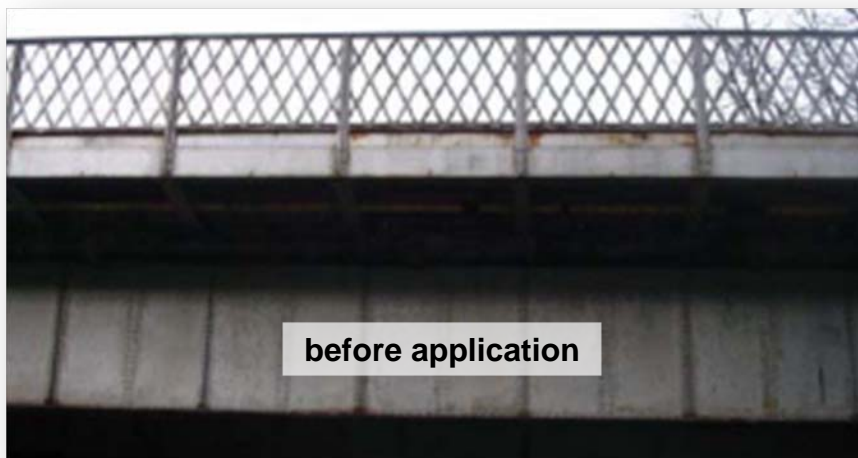
In the last decade it was showing rapid deterioration caused by corrosion.

**Site inspection May 2007.
Note the increased beam corrosion.**

The old coating had to be removed completely because of this rapid advancement of corrosion.

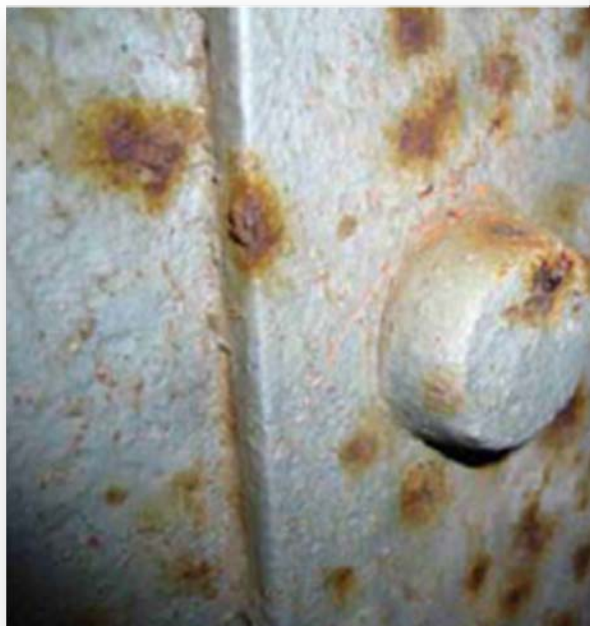
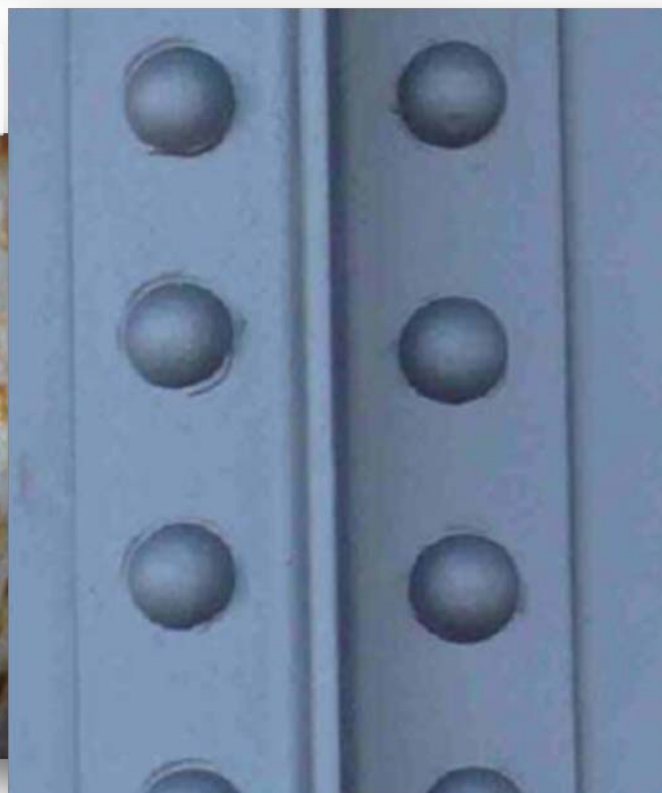
**Typical view of coated steelwork.
All rivets, edges and bolts were stripe coated.**

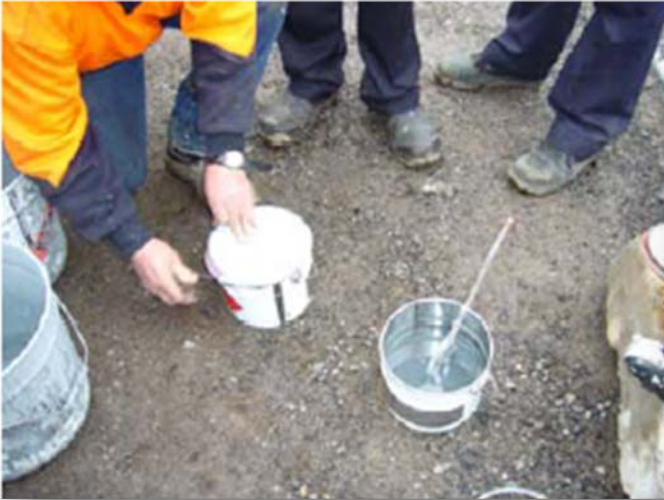
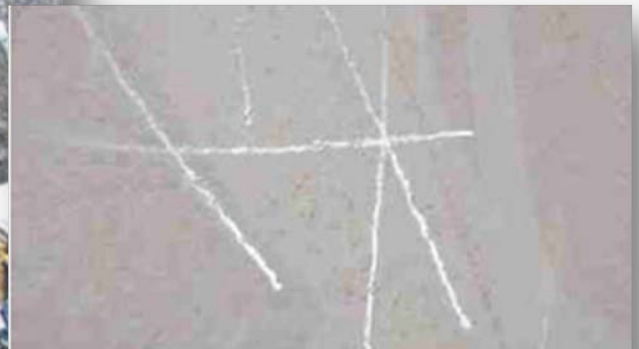
Photo Shows ZINGA “Liquid Galvanising”.
Scratched with coin.
Note: the pure zinc exposed.
